123 Sample Property Ln, Anywhere, IN 47018

# Home Inspection Report

Sample Client

Dan Tinsley / Valor Home Inspections

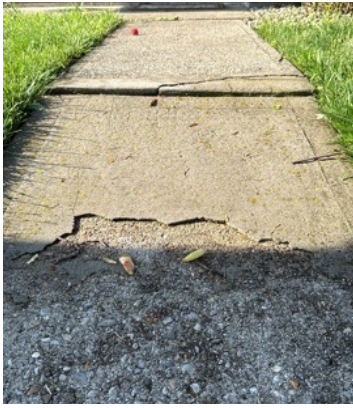
Location - North

### Uneven and Cracked Walkway Creating Trip Hazard

The exterior walkway was observed to be uneven and cracked, creating a potential trip hazard. This condition may pose a safety risk to occupants and visitors, especially in low visibility conditions. It is recommended that the damaged sections be repaired, leveled, or replaced to provide a stable and even walking surface. A qualified contractor should evaluate the extent of the deterioration and perform appropriate corrective measures to reduce the risk of injury.

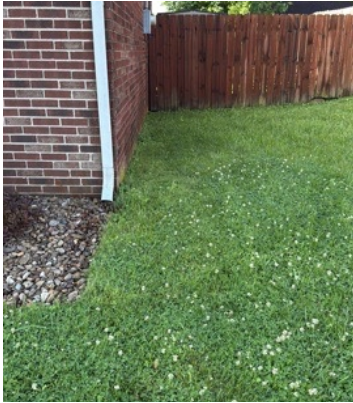
Location - West, South

West Side appeared to have negative slope towards foundation. Recommend evaluation by qualified contractor for any moisture issues.

South side appeared to have negative slope toward foundation. Recommend evaluation by qualified contractor for any moisture issues.

Requires Attention Recommendation

Improper slope. Pitch grading so that the water drains away from the house.

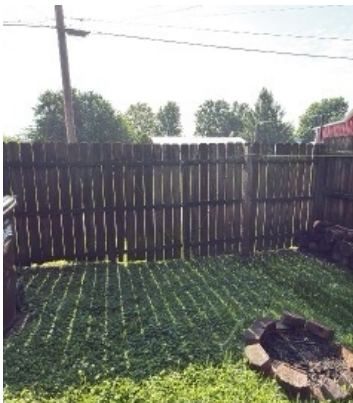
Location - East

The wood privacy fence shows signs of weathering and deterioration, including discoloration and surface wear. Several sections appear slightly warped and uneven, and the gate appears misaligned with adjacent panels.

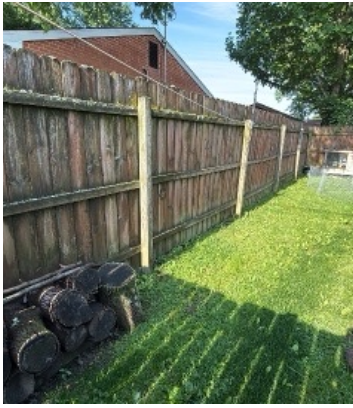
Location - South

**Weathered and Leaning Wood Fence with Moisture Damage**

The wood fence exhibits visible weathering and discoloration, with signs of aging including warped and uneven pickets. Some sections appear to be leaning slightly, and there is evidence of moisture-related deterioration along the lower portions of the boards.

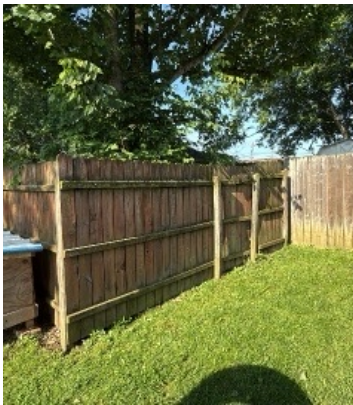
Location - South

**Weathered and Leaning Wood Fence Sections**

Wood fencing shows signs of weathering and discoloration, with areas of green staining consistent with moisture exposure. Sections of the fence appear slightly leaning and some boards are warped or uneven, indicating minor structural movement and deterioration.

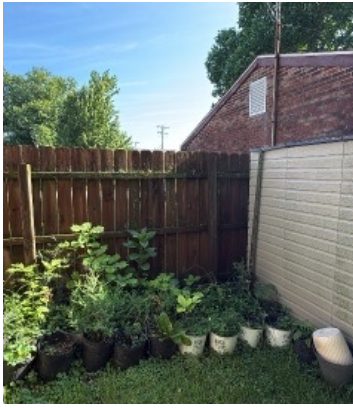
Location - North, West

**Weathered and Slightly Leaning Wood Fence with Vegetation Contact**

The wood fence is weathered, shows slight leaning, and has vegetation in contact along sections. These conditions can accelerate deterioration, reduce stability, and shorten the fence's service life. Recommend trimming back vegetation to prevent moisture retention and further damage. Evaluate posts and supports for integrity; repair or reinforce leaning sections as needed. Replacement of severely weathered or compromised components may be necessary to restore proper function and longevity.

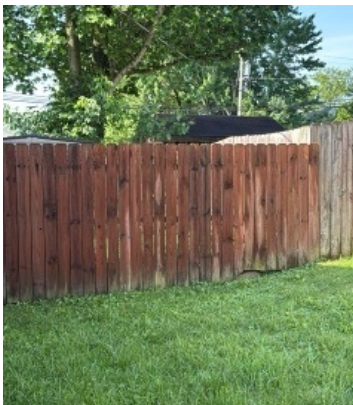
Location - West

**Weathered Fence with Moisture Damage and Minor Leaning**

The wood fence exhibits noticeable weathering and discoloration, with sections showing uneven fading and staining. There is visible moisture-related deterioration at the lower portions, including dark staining consistent with algae or rot. Some boards appear slightly warped and misaligned, and the fence line shows minor leaning.

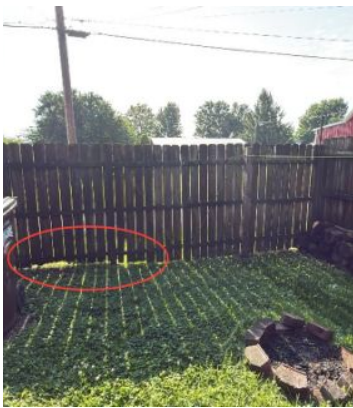
East

Damaged, recommend repair/replacement

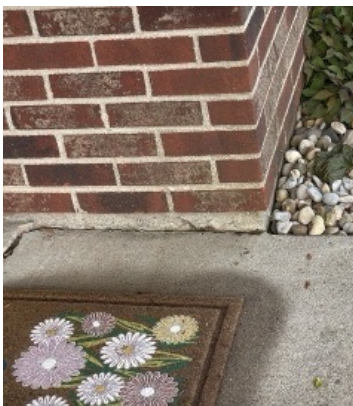
Location - North

Cracked and Separated Concrete at Porch Entry

Cracking and separation were observed in the concrete slab at the porch/patio area near the brick wall and entry door. The gap at the joint appears widened and may allow water intrusion, which can contribute to further deterioration or potential settlement. This condition also presents a potential trip hazard. Recommend sealing the joint and having the area evaluated and repaired by a qualified contractor to prevent further damage and improve safety.

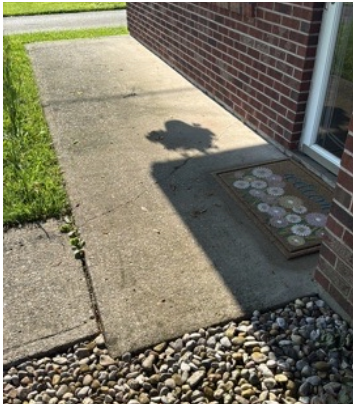
Location - North

Cracked Concrete Porch Slab

Cracking was observed in the concrete porch slab, including a visible fracture extending across the surface near the entry area. Minor separation is also noted at the joint between slab sections.

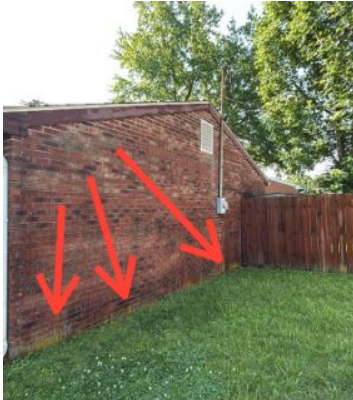
Location - West

**Improper Drainage**

Improper drainage was observed around the exterior, along with visible staining on adjacent surfaces. This condition can lead to moisture intrusion, material deterioration, and potential foundation concerns over time. Recommend improving site grading to direct water away from the structure and ensuring gutters and downspouts discharge properly. Monitor affected areas for further changes and consider consulting a qualified contractor to address drainage deficiencies.

Evidence of prolonged moisture exposure and organic growth staining was observed at the lower section of the brick veneer wall. Conditions may be associated with poor drainage, splash-back, elevated soil/moisture contact, or improper downspout discharge near the foundation. Recommend improving drainage away from the structure, monitoring for signs of moisture intrusion, and further evaluation/cleaning by a qualified masonry contractor as

needed. Continued moisture exposure can contribute to premature deterioration of masonry materials and mortar joints.

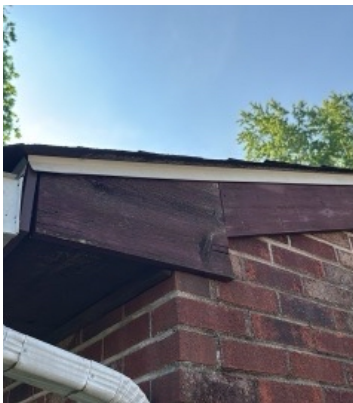
Location - Northwest

### Deteriorated Fascia and Moisture Staining at Eave

Localized deterioration and weathering were observed at the fascia board, including peeling/failed paint, discoloration, and possible early-stage wood rot at the joint near the gutter. The soffit area below appears to show staining consistent with moisture exposure. These conditions may be related to water intrusion or inadequate drainage at the gutter edge. Recommend repairing or replacing damaged fascia sections, sealing and repainting all exposed wood, and verifying proper gutter alignment and drip edge installation to prevent further moisture damage.

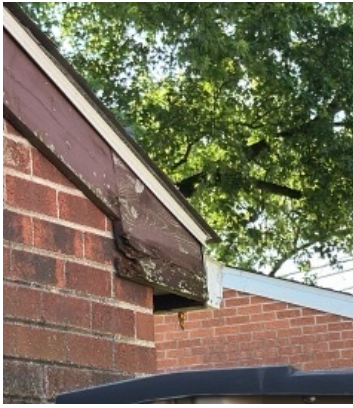
Location - Southwest

### Rotted and Deteriorated Fascia/Soffit Components

Deterioration and apparent wood rot were observed at the fascia/soffit area, including peeling paint, decayed wood, and visible gaps. These conditions are consistent with prolonged moisture exposure and may allow for pest intrusion and further structural damage if left unaddressed. Recommend repair or replacement of the affected wood components, followed by proper sealing and painting to protect against future moisture intrusion. Evaluate adjacent areas for additional hidden damage.

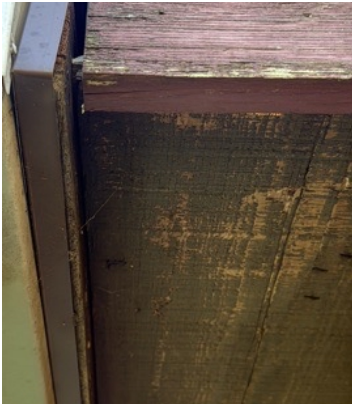
**Deteriorated Soffit/Fascia with Early Rot**

The soffit/fascia wood shows significant weathering and deterioration, including peeling paint, surface degradation, and possible early-stage rot along the edge. The exposed wood is vulnerable to moisture intrusion and further decay. Recommend repairing or replacing damaged sections as needed, followed by proper sealing, priming, and painting to protect against future deterioration. Also advise verifying that adjacent flashing and drainage components are properly directing water away from this area.

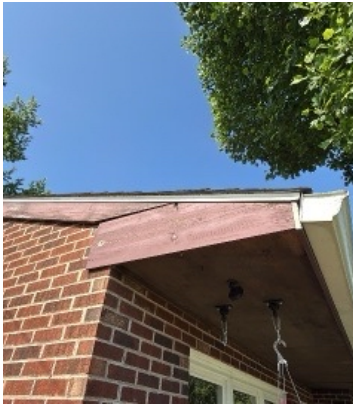
Location - Northeast

**Warped and Deteriorated Fascia Board**

The fascia board at the roof edge shows signs of warping and deterioration, with visible separation and uneven alignment along the trim. The wood appears weathered with peeling or faded finish, indicating prolonged exposure to moisture. These conditions can allow water intrusion and lead to further structural damage if not addressed. Recommend repair or replacement of the affected fascia sections, followed by proper sealing and painting to protect against future moisture damage.

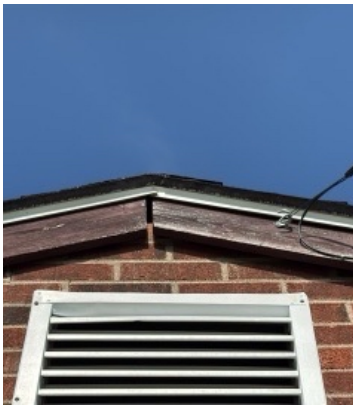
Location - East

**Weathered and Deteriorating Fascia**

The fascia boards at the gable end show signs of weathering, including peeling paint and surface deterioration. There are minor gaps at the joints and exposed wood, which may allow moisture intrusion and lead to further decay if not addressed.

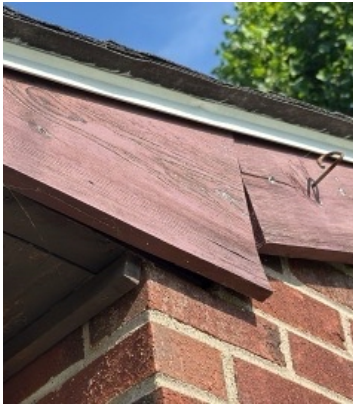
Location - Southeast

**Damaged and Splitting Fascia Board with Deteriorated Finish**

The fascia board at the roof edge shows visible cracking, splitting, and warping, with sections beginning to separate. The paint/finish is deteriorated, leaving the wood exposed to moisture intrusion and potential rot. These conditions can allow water penetration and pest entry if not addressed. Recommend repair or replacement of the damaged fascia sections, followed by proper sealing and repainting to protect against further deterioration. Evaluate adjacent soffit and roof edge components for any hidden moisture damage and repair as needed.

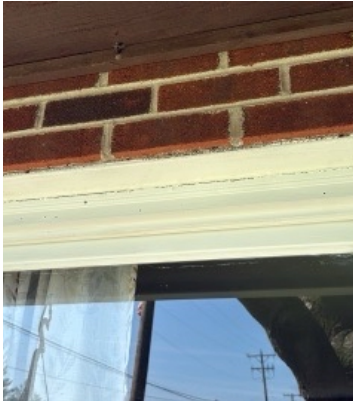
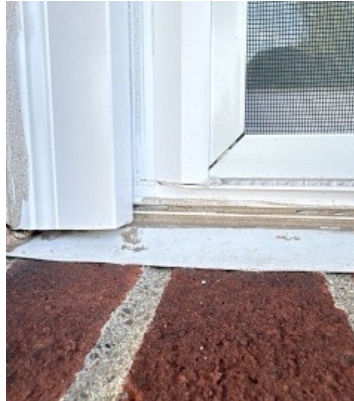
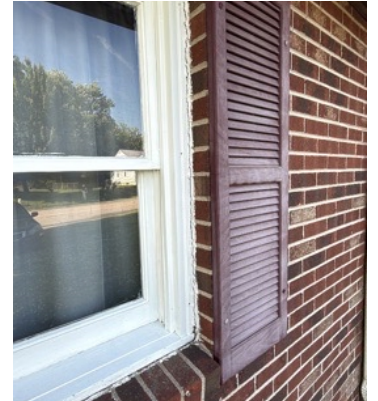
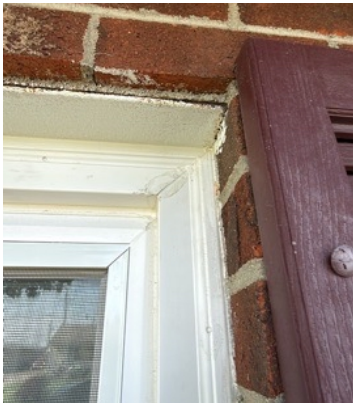
Deteriorated Window Head/ Perimeter Sealant and Gaps

Deterioration and gaps were observed at the top of the window trim where it meets the brick veneer. Sealant appears aged, cracked, or missing in areas, which can allow moisture intrusion and potential damage to surrounding materials. Recommend cleaning, properly sealing/caulking, and repainting the affected areas. Further evaluation for concealed moisture damage is advised if signs of water intrusion are present.

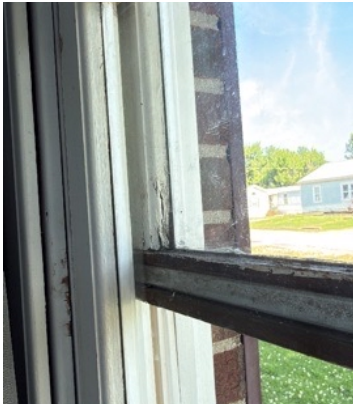
Location - Northwest, Bedroom

Deteriorated Window Frame and Sill with Paint Failure

Deterioration is visible on the window frame and sill, including peeling paint and apparent areas of wood rot. The lower sash track also shows signs of wear and possible corrosion.

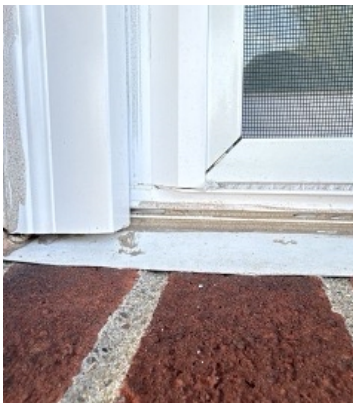
Location - North, Bedroom

**Deteriorated Sealant and Finish at Window Sill**

Deteriorated sealant and finish were observed at the window sill. This condition can allow moisture intrusion, which may lead to wood rot, interior damage, or reduced energy efficiency. Recommend removing failed materials, properly preparing the surface, and resealing/refinishing the sill with appropriate exterior-grade products. Monitor for any signs of water intrusion inside the home and repair as needed. Consider having a qualified contractor perform the work to ensure proper sealing and durability.

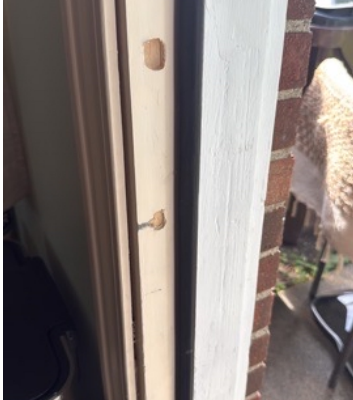
Location - Kitchen

Missing Strike Plate and Improper Door Latching

The exterior door frame shows evidence of missing or removed strike plate hardware, with mounting holes filled or patched. This condition may prevent the door from latching and securing properly and can reduce overall security. Recommend installation of a proper strike plate and associated hardware, and repair of the door jamb as needed to ensure the door closes and latches securely.

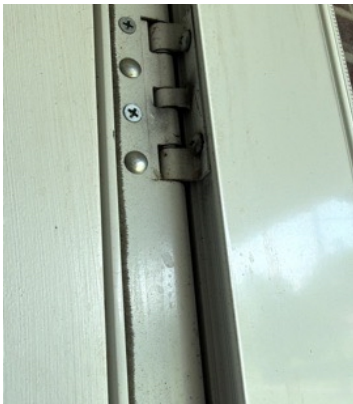
Location - Living room

**Loose and Worn Exterior Door Hinge**

The exterior door hinge shows signs of dirt buildup and wear, and one or more screws appear not fully seated, which may indicate loosening over time. This condition can affect proper door operation and alignment. Recommend cleaning the hinge, tightening all fasteners, and replacing any stripped or damaged screws. Lubrication of the hinge is also advised to ensure smooth operation and reduce further wear.

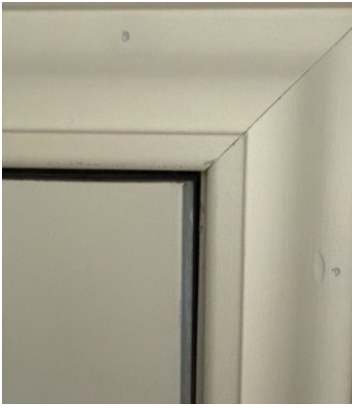
Location - Living room

The exterior door trim at the upper corner shows separation at the miter joint, with visible gaps and minor cracking in the finish. This condition may allow moisture intrusion and can worsen over time if not addressed. Recommend sealing the joint with appropriate exterior-grade caulk and monitoring for further movement; repair or replacement of trim may be needed if separation increases.

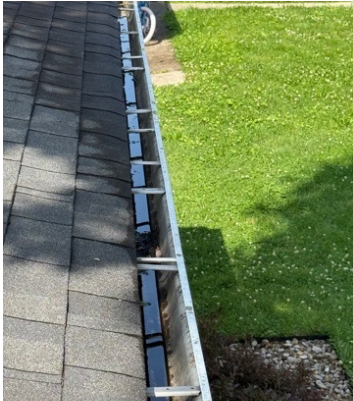
Location - North

Standing Water in Gutter Due to Improper Slope

The gutter contains standing water and debris accumulation, indicating improper drainage and likely insufficient slope toward the downspout. Prolonged standing water can lead to

accelerated deterioration, overflow, and potential damage to the fascia and foundation areas below. Recommend cleaning the gutters and having a qualified contractor evaluate and correct the pitch to ensure proper drainage.

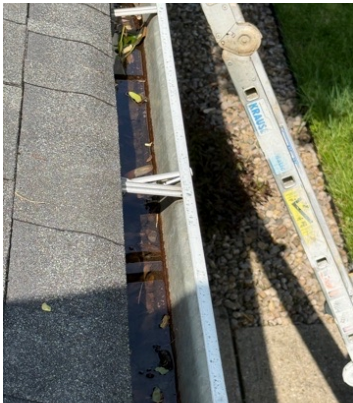
Location - North, South

**Clogged Gutter with Standing Water and Improper Drainage**

The gutter contains standing water and accumulated debris, indicating improper drainage and likely blockage. Prolonged water retention can accelerate corrosion and may lead to overflow, potentially causing damage to the fascia, soffit, and foundation areas below. Recommend cleaning the gutters, ensuring proper slope toward downspouts, and evaluating for any obstructions or damage. Consider routine maintenance to prevent recurrence.

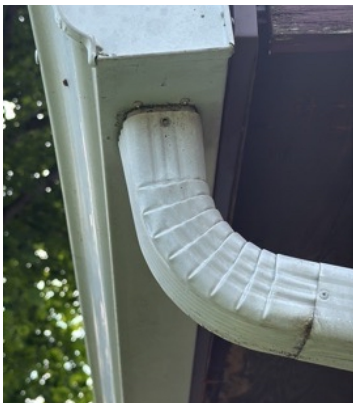
Location - Northwest

**Loose and Leaking Downspout Connection at Gutter Outlet**

The downspout elbow connection at the gutter outlet appears loosely fitted and inadequately sealed, with visible gaps and staining consistent with water leakage. Fastening at the connection also appears insufficient. This condition can allow water to escape at the joint and contribute to moisture intrusion and damage to adjacent components. Recommend properly securing the connection with appropriate fasteners and sealing the joint to ensure a water-tight fit.

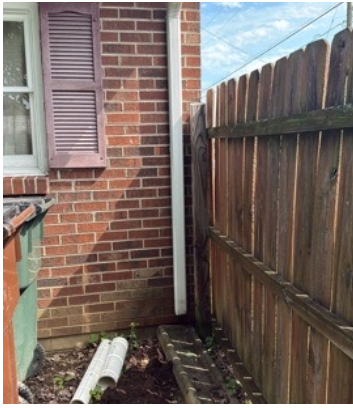
Location - Southeast

**Downspout Extension Missing/Not Connected**

The downspout terminates at the foundation and is not properly connected to an extension to carry water away. Extension pieces were observed on the ground nearby but are not installed. This condition can allow water to accumulate at the foundation, increasing the risk of moisture intrusion or structural movement. Recommend installing and securing a proper downspout extension to direct water at least 4–6 feet away from the foundation and ensuring positive drainage away from the structure.

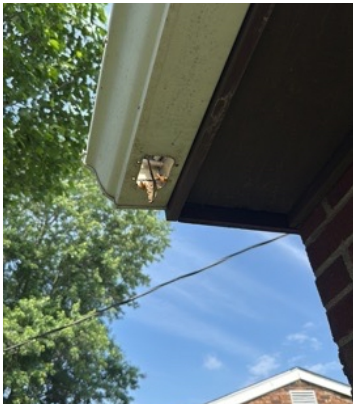
Location - Southwest

**Missing Downspout and Improper Drainage at Gutter Outlet**

The gutter downspout is missing at this location, leaving an open outlet at the end of the gutter. This condition allows water to discharge directly at the roof edge and near the foundation, which can lead to soil erosion, moisture intrusion, and potential foundation damage. Debris buildup is also visible at the outlet, which may further restrict proper drainage. Recommend installing a properly connected downspout with an extension to direct water away from the structure and cleaning the gutter to ensure proper flow.

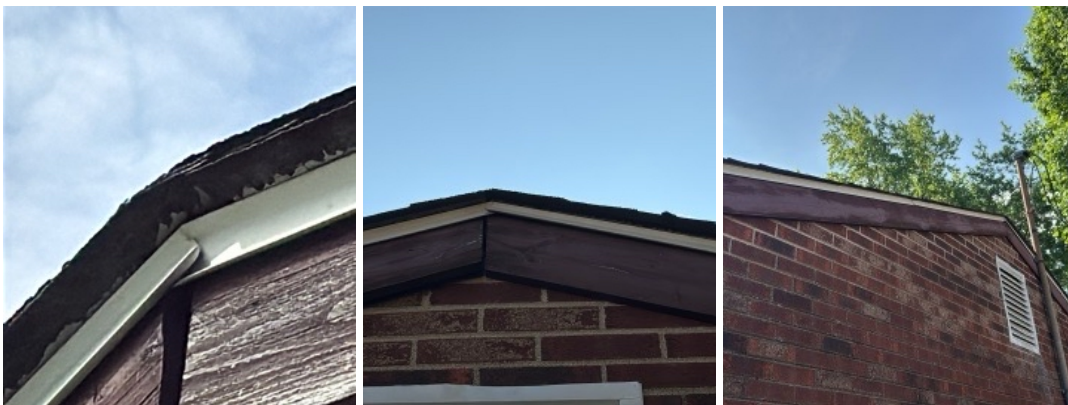
Location - East

**Missing/Deteriorated Roof Edge Flashing**

Exposed wood and deteriorated/missing flashing were observed along the roof edge. The drip edge/flashing appears incomplete or improperly installed, which can allow water intrusion and contribute to wood rot at the fascia. Recommend evaluation and repair by a qualified roofing contractor, including installation of proper flashing and replacement of any damaged wood to help prevent further deterioration.

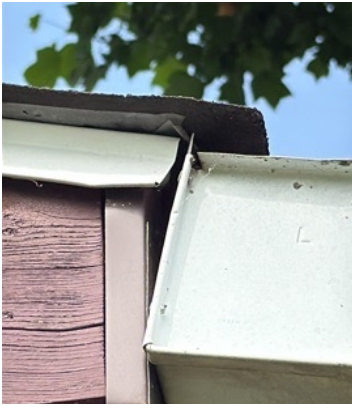
Location - Northwest, Northeast, Southwest, Southeast

**Improper/Loose Roof Edge Flashing at Gutter**

Flashing at the roof edge above the gutter appears improperly installed and/or damaged, with visible gaps and lifting that can allow water intrusion behind the gutter. Exposed wood trim is present and may be susceptible to moisture damage and decay. Recommend evaluation and repair by a qualified contractor to properly install or secure flashing and seal all gaps to prevent water penetration.

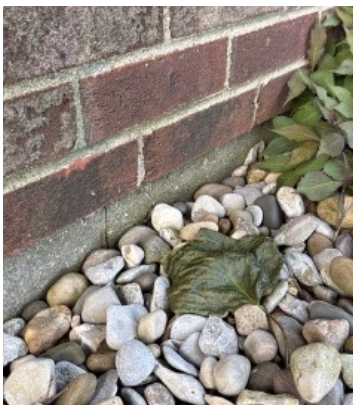
Location - North

**Minor Foundation Crack and Moisture Concern at Base of Wall**

A small crack and separation were observed at the base of the foundation wall where the concrete meets the brick veneer. This condition may allow moisture intrusion and could worsen over time if not addressed. Additionally, the presence of landscaping stones in direct contact with the foundation may contribute to moisture retention against the wall. Recommend sealing the crack with an appropriate masonry sealant and maintaining proper clearance between the foundation and landscaping materials. Monitor the area for any signs of movement or water intrusion and consult a qualified contractor if the condition worsens.

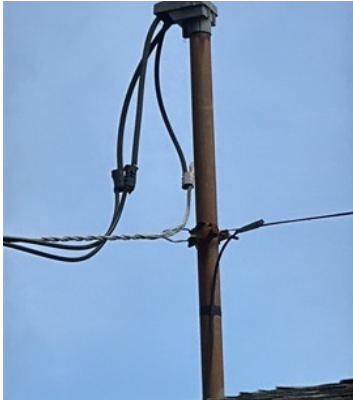
Location - West

**Corroded Electrical Service Mast**

The overhead electrical service mast shows visible corrosion and deterioration at the attachment point and along the mast surface. These conditions can lead to premature failure, water intrusion, or unsafe electrical connections. Recommend evaluation and repair by a licensed

electrician, including replacement of corroded components, proper securing of conductors, and verification of a watertight, code-compliant installation.

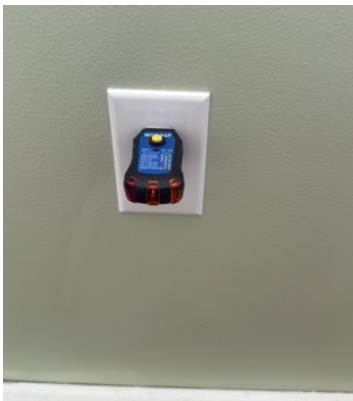
Location - Living room below windows

Outlet appears to not be energized

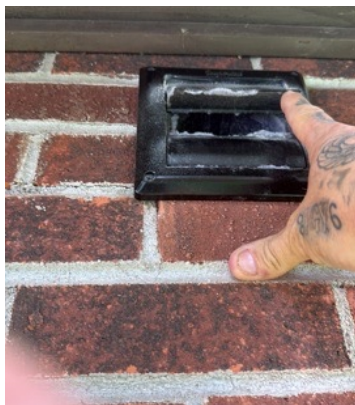
Lint buildup was observed at the exterior dryer vent termination, and the vent flap appears obstructed and not fully closing. This condition can restrict airflow, reduce dryer efficiency, and increase the risk of overheating or fire. Recommend cleaning the vent and ensuring the damper operates freely; repair or replace the vent cover if it does not properly open and close.
