123 Sample Property Ln, Anywhere, IN 47018

# Home Inspection Report

Sample Client

Dan Tinsley / Valor Home Inspections

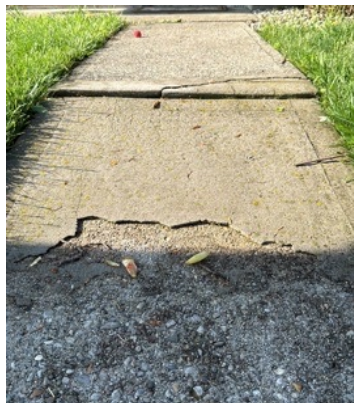
### Uneven and Cracked Walkway Creating Trip Hazard

The exterior walkway was observed to be uneven and cracked, creating a potential trip hazard. This condition may pose a safety risk to occupants and visitors, especially in low visibility conditions. It is recommended that the damaged sections be repaired, leveled, or replaced to provide a stable and even walking surface. A qualified contractor should evaluate the extent of the deterioration and perform appropriate corrective measures to reduce the risk of injury.

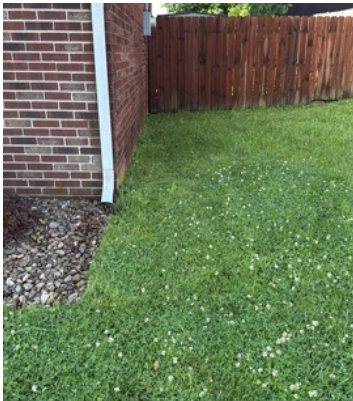
West Side appeared to have negative slope towards foundation. Recommend evaluation by qualified contractor for any moisture issues.

Improper slope. Pitch grading so that the water drains away from the house.

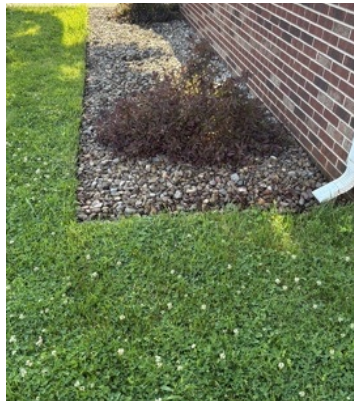
North Side

North side appeared to have positive slope away from foundation.

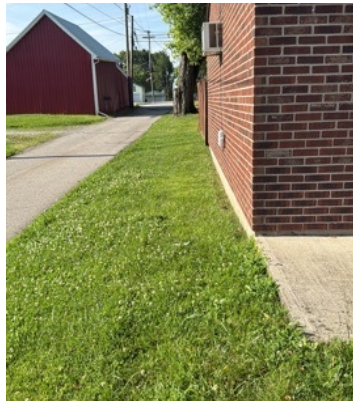
East Side appeared to have positive slope away from foundation.

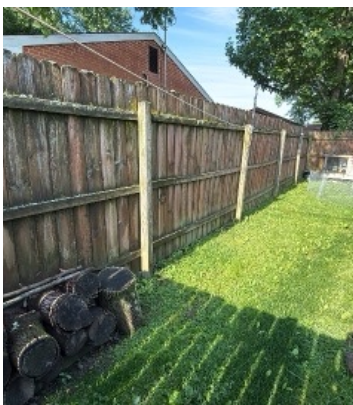
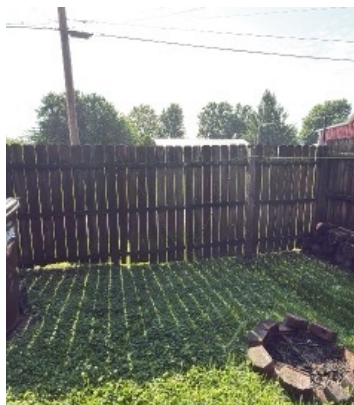
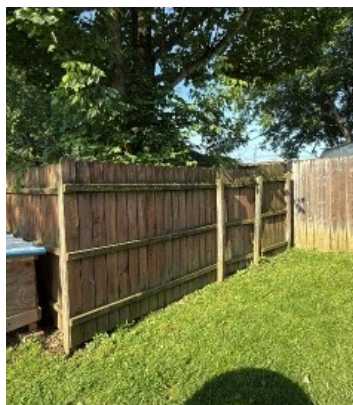
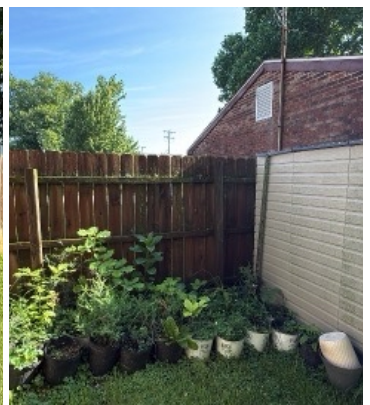
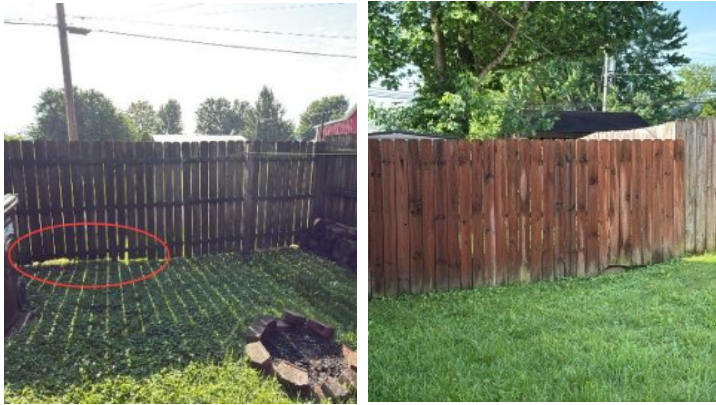
The wood privacy fence shows signs of weathering and deterioration, including discoloration and surface wear. Several sections appear slightly warped and uneven, and the gate appears misaligned with adjacent panels.

The wood fence exhibits visible weathering and discoloration, with signs of aging including warped and uneven pickets. Some sections appear to be leaning slightly, and there is evidence of moisture-related deterioration along the lower portions of the boards.

Wood fencing shows signs of weathering and discoloration, with areas of green staining consistent with moisture exposure. Sections of the fence appear slightly leaning and some boards are warped or uneven, indicating minor structural movement and deterioration.

The wood fence is weathered, shows slight leaning, and has vegetation in contact along sections. These conditions can accelerate deterioration, reduce stability, and shorten the fence's service life. Recommend trimming back vegetation to prevent moisture retention and further damage. Evaluate posts and supports for integrity; repair or reinforce leaning sections as needed. Replacement of severely weathered or compromised components may be necessary to restore proper function and longevity.

The wood fence exhibits noticeable weathering and discoloration, with sections showing uneven fading and staining. There is visible moisture-related deterioration at the lower portions, including dark staining consistent with algae or rot. Some boards appear slightly warped and misaligned, and the fence line shows minor leaning.

A section of the fence is in direct contact with the exterior wall, and deterioration is visible at the bottom of the fence materials. This condition can trap moisture against the wall and accelerate decay or pest intrusion. It is recommended to separate the fence from the structure to allow proper airflow and prevent moisture buildup. Damaged portions of the fence should be repaired or replaced as needed. Monitor the adjacent wall area for any signs of moisture damage and address if observed.

Damaged, recommend repair/replacement

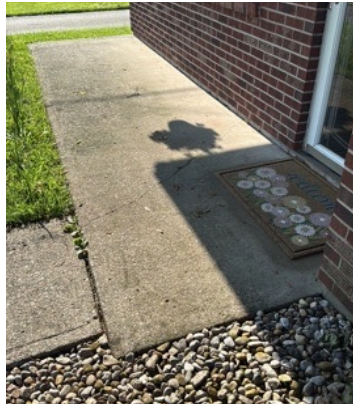
Front Porch

Cracked and Separated Concrete at Porch Entry

Cracking and separation were observed in the concrete slab at the porch/patio area near the brick wall and entry door. The gap at the joint appears widened and may allow water intrusion, which can contribute to further deterioration or potential settlement. This condition also presents a potential trip hazard. Recommend sealing the joint and having the area evaluated and repaired by a qualified contractor to prevent further damage and improve safety.

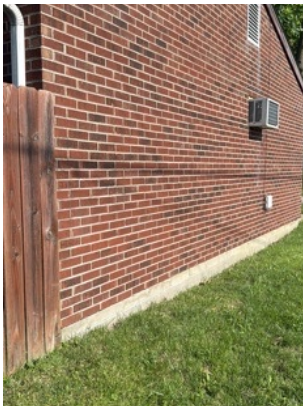
Location - East

**No Visible Issues Observed**

No visible issues were observed.

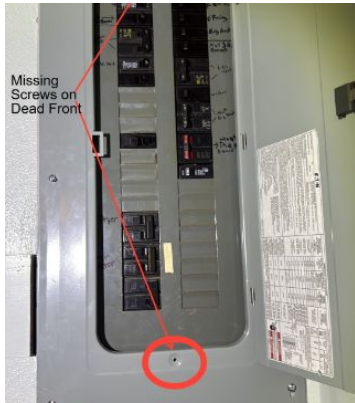
Location - Northwest, Bedroom, Closet

The main electrical panel appears generally intact; however, there are breakers installed that appear to be of differing brands/types, which may not be listed or approved for use within this specific panel. Mixing incompatible breakers can lead to poor connections, overheating, or unreliable circuit protection. Additionally, the circuit directory is handwritten and somewhat unclear in areas, which may make it difficult to quickly identify and safely shut off individual circuits during an emergency or when servicing is needed. It is recommended that a qualified licensed electrician evaluate the panel to confirm that all breakers are properly matched and approved for this panel model, and replace any incompatible components as needed. The electrician should also provide a clear, legible, and accurate circuit directory for improved safety and usability.

Evaluation by a licensed electrician is recommended

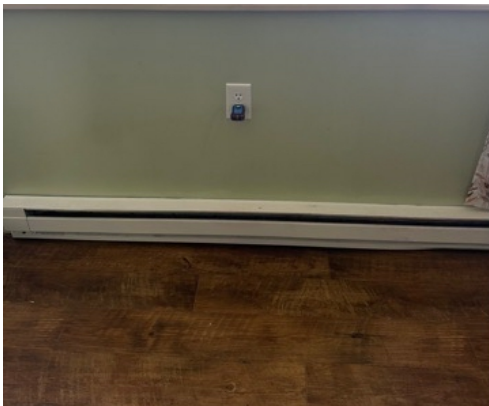
Location - Living room

A standard receptacle was observed in this location without visible AFCI protection. While not all areas require GFCI protection, modern safety standards typically call for AFCI protection in living areas. The absence of visible protection could indicate the circuit is not adequately protected or protection may be located upstream and not labeled. Recommend verification of proper GFCI/AFCI protection and upgrading as needed by a qualified electrician to enhance safety. Additionally, this particular outlet appeared, according to tester, to not be energized.

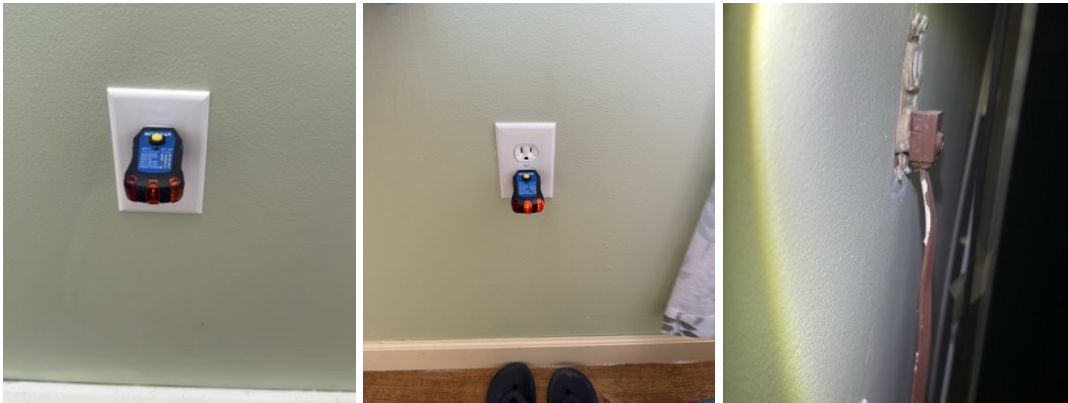
Living Room Wall Under Windows

no power to outlet, recommend licensed electrician evaluate

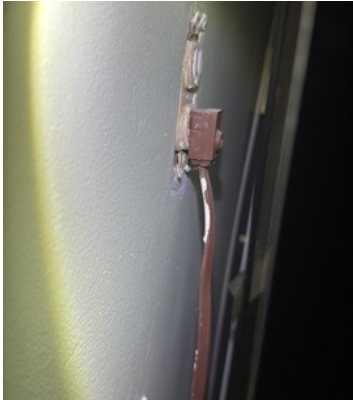
Location - Kitchen behind Refrigerator

Cover missing from box

An electrical outlet was observed without a cover plate. This condition exposes wiring and terminals, increasing the risk of electrical shock and potential damage to the outlet. It is rec-

ommended that a proper cover plate be installed to protect the outlet and restore safe conditions. Repair should be completed by a qualified individual prior to normal use.

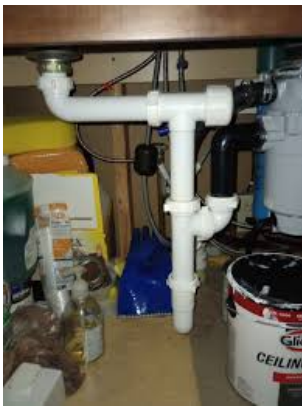
No Visible Leaks at time of inspection

Finishes block visual inspection of drain/sewer lines. Recommend a sewer scope inspection.

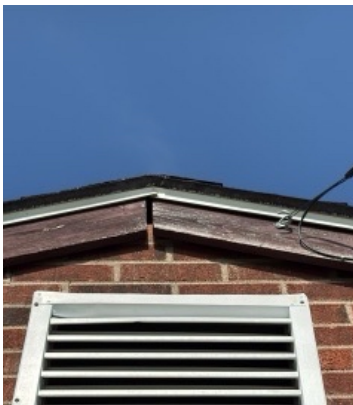
Location - Attic

The attic space was not accessible at the time of inspection due to restricted or blocked entry. As a result, the condition of the attic, including insulation, ventilation, and structural components, could not be evaluated. It is recommended that access be provided and the attic be inspected once entry is made available. Consider having a qualified professional assess the area to ensure there are no hidden issues such as moisture intrusion, pest activity, or structural concerns.

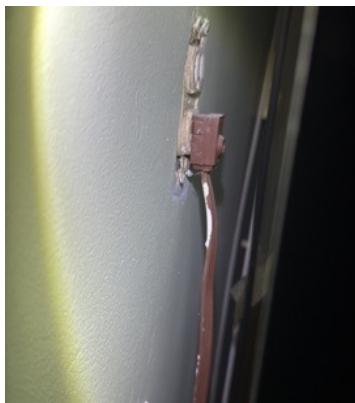
Location - Kitchen

Install missing outlet cover plate

An outlet in the kitchen is missing its cover plate, leaving wiring components exposed. This condition poses a potential shock hazard and should be addressed promptly. Recommend installing a proper cover plate to ensure safety and protect the outlet from damage. If the

outlet appears damaged or loose, a qualified electrician should evaluate and repair as needed.

Recommend that a qualified contractor evaluate and estimate repairs

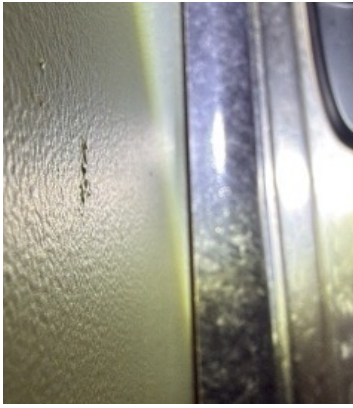
Caulk the edge(s) of the counter and backsplash

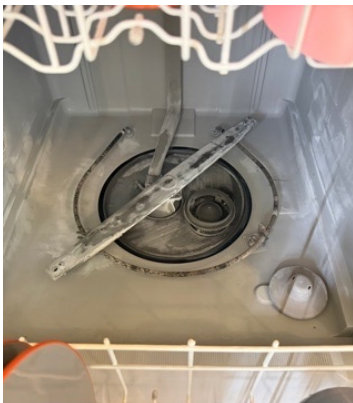
Location - Kitchen

Standing water observed in the bottom of the dishwasher along with visible debris and residue accumulation around the drain area. Mineral buildup appeared to be present on interior surfaces.

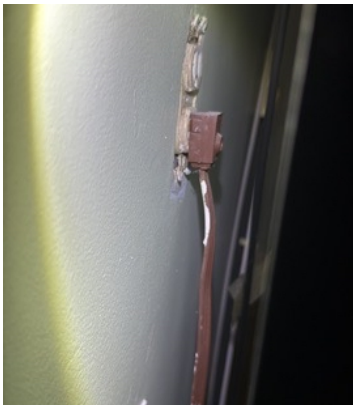
Location - Kitchen

Exposed and improperly terminated wiring was observed at the wall surface, with no protective junction box or cover in place. The wall opening around the wiring is damaged, and the conductor appears unsecured and vulnerable to physical damage. This condition presents a potential safety hazard and does not meet typical electrical safety standards. Recommend evaluation and repair by a qualified electrician to properly enclose, secure, and protect the wiring, and to repair the wall surface as needed.

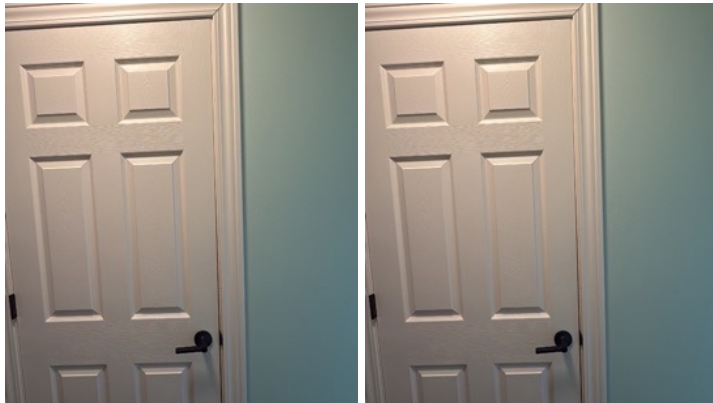
Location - Utility Closet

The door is sticking

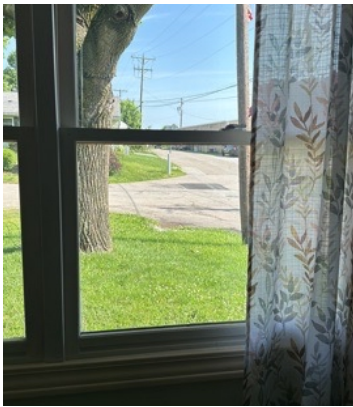
Location - Far East Living Room Window

Will not open

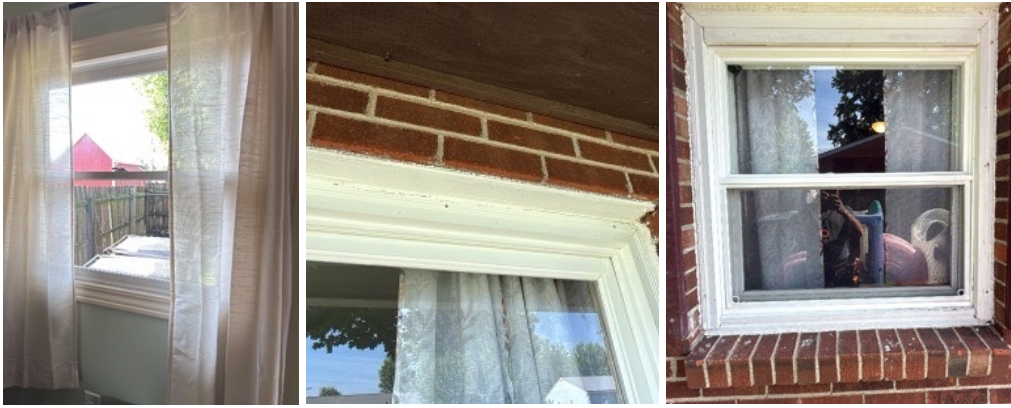
Location - Kitchen, Bedroom, Living room

**Window panes missing seals**

One or more window panes were observed with failed or missing seals. This condition can allow air and moisture infiltration, reducing energy efficiency and potentially leading to condensation or fogging between panes. It is recommended that a qualified window contractor evaluate the affected units and repair or replace the seals or glazing as needed to restore proper performance.

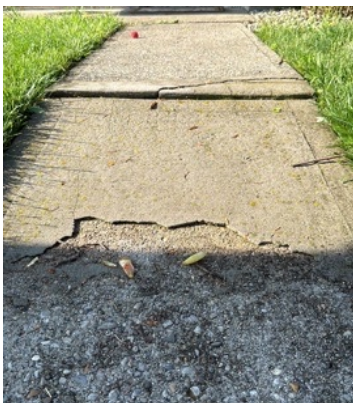
Location - North

#### Uneven and Cracked Walkway Creating Trip Hazard

The exterior walkway was observed to be uneven and cracked, creating a potential trip hazard. This condition may pose a safety risk to occupants and visitors, especially in low visibility conditions. It is recommended that the damaged sections be repaired, leveled, or replaced to provide a stable and even walking surface. A qualified contractor should evaluate the extent of the deterioration and perform appropriate corrective measures to reduce the risk of injury.

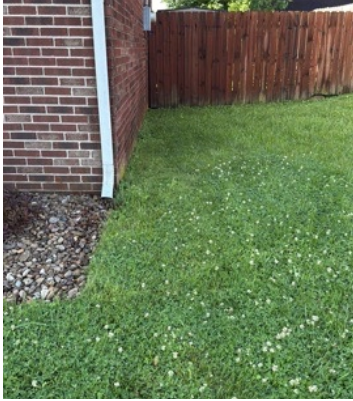
Location - West, South

Improper slope. Pitch grading so that the water drains away from the house.

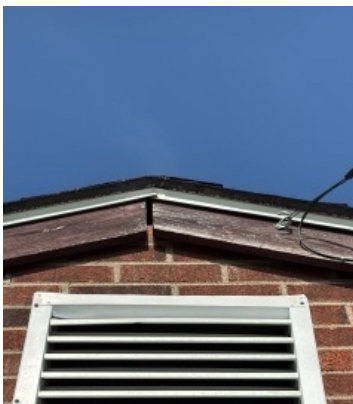
Location - East

**Weathered and Deteriorating Fascia**

The fascia boards at the gable end show signs of weathering, including peeling paint and surface deterioration. There are minor gaps at the joints and exposed wood, which may allow moisture intrusion and lead to further decay if not addressed.

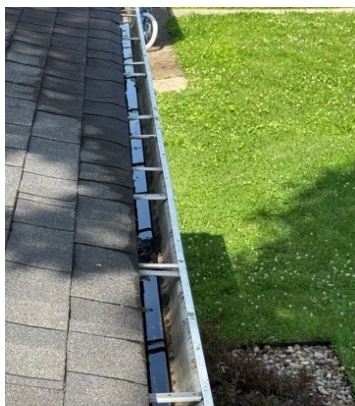
Location - North

**Standing Water in Gutter Due to Improper Slope**

The gutter contains standing water and debris accumulation, indicating improper drainage and likely insufficient slope toward the downspout. Prolonged standing water can lead to accelerated deterioration, overflow, and potential damage to the fascia and foundation areas below. Recommend cleaning the gutters and having a qualified contractor evaluate and correct the pitch to ensure proper drainage.

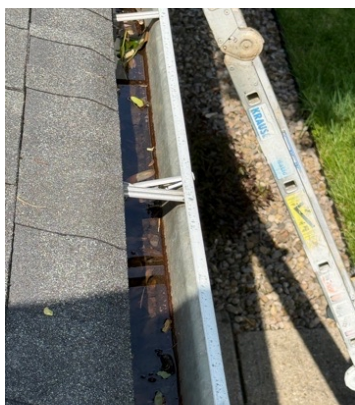
Location - North, South

**Clogged Gutter with Standing Water and Improper Drainage**

The gutter contains standing water and accumulated debris, indicating improper drainage and likely blockage. Prolonged water retention can accelerate corrosion and may lead to overflow, potentially causing damage to the fascia, soffit, and foundation areas below. Recommend cleaning the gutters, ensuring proper slope toward downspouts, and evaluating for any obstructions or damage. Consider routine maintenance to prevent recurrence.

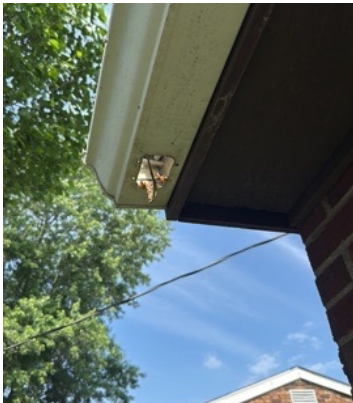
Location - Southwest

**Missing Downspout and Improper Drainage at Gutter Outlet**

The gutter downspout is missing at this location, leaving an open outlet at the end of the gutter. This condition allows water to discharge directly at the roof edge and near the foundation, which can lead to soil erosion, moisture intrusion, and potential foundation damage. Debris buildup is also visible at the outlet, which may further restrict proper drainage. Recommend installing a properly connected downspout with an extension to direct water away from the structure and cleaning the gutter to ensure proper flow.

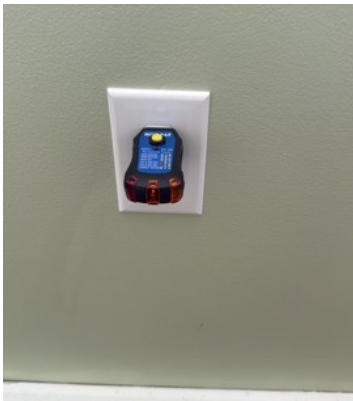
Location - Living room below windows

An electrical outlets were found to be not energized at the time of inspection. No tripped breakers were observed at the main panel, suggesting a possible wiring issue, loose connection, or a fault within the circuit. This condition may limit usability and could indicate an underlying defect. Recommend evaluation and repair by a qualified licensed electrician to determine the cause and restore proper function.

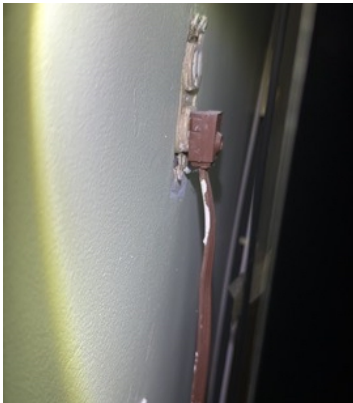
Location - Kitchen

Exposed and improperly terminated wiring was observed at the wall surface, with no protective junction box or cover in place. The wall opening around the wiring is damaged, and the conductor appears unsecured and vulnerable to physical damage. This condition presents a potential safety hazard and does not meet typical electrical safety standards. Recommend evaluation and repair by a qualified electrician to properly enclose, secure, and protect the wiring, and to repair the wall surface as needed.

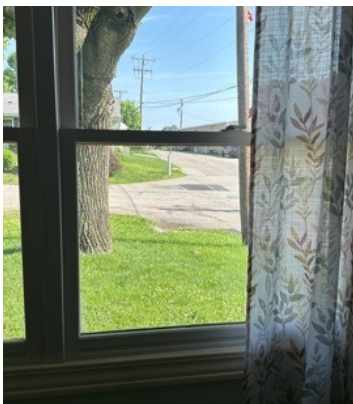
Location - Far East Living Room Window

**Will not open**
